# **An introduction to the Foster Freeman Video Spectral Comparator: VSC8000HS**

A Zoom Presentation to the NZ GB Philatelic Society,  
29<sup>th</sup> April 2023

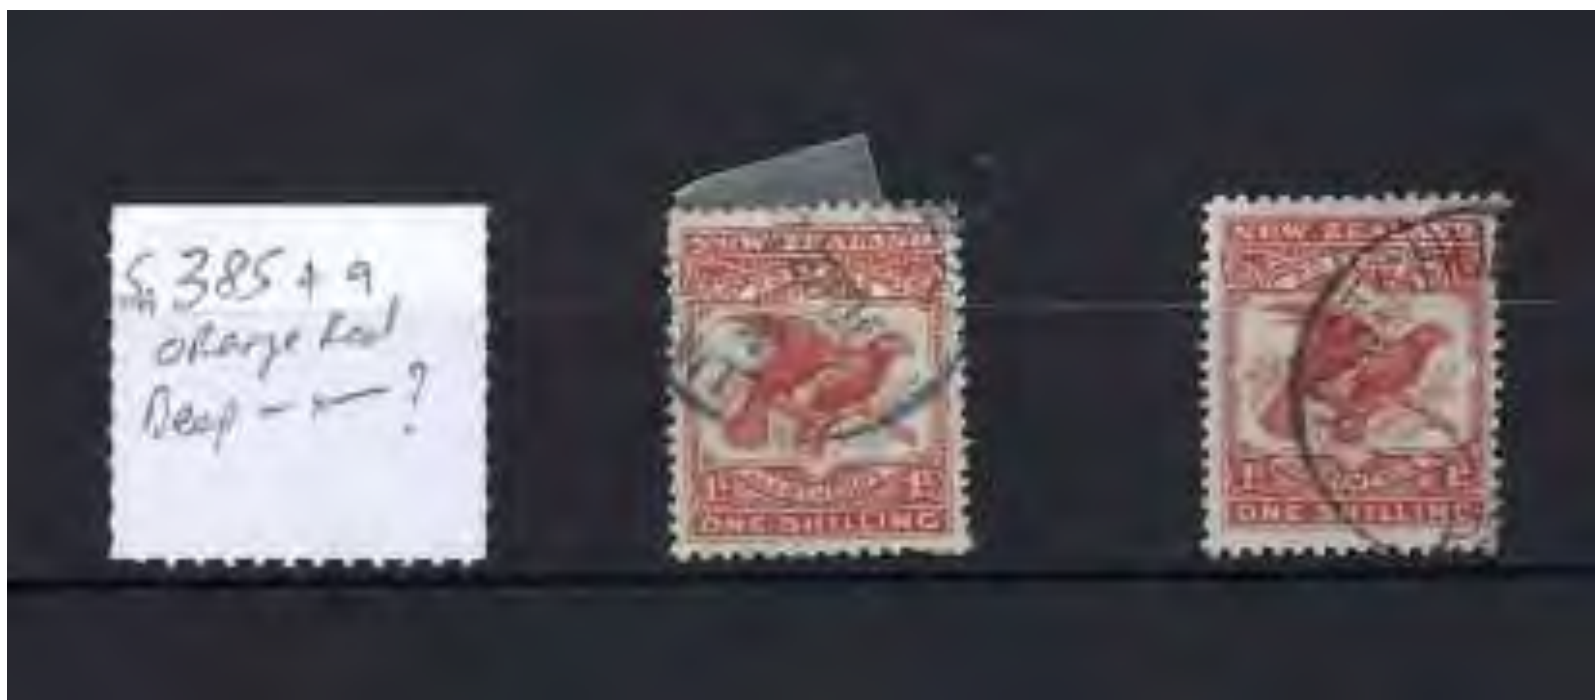
NZ SG385 or SG385a ( or SG381~ orange brown ?)  
Orange red or deep orange brown?

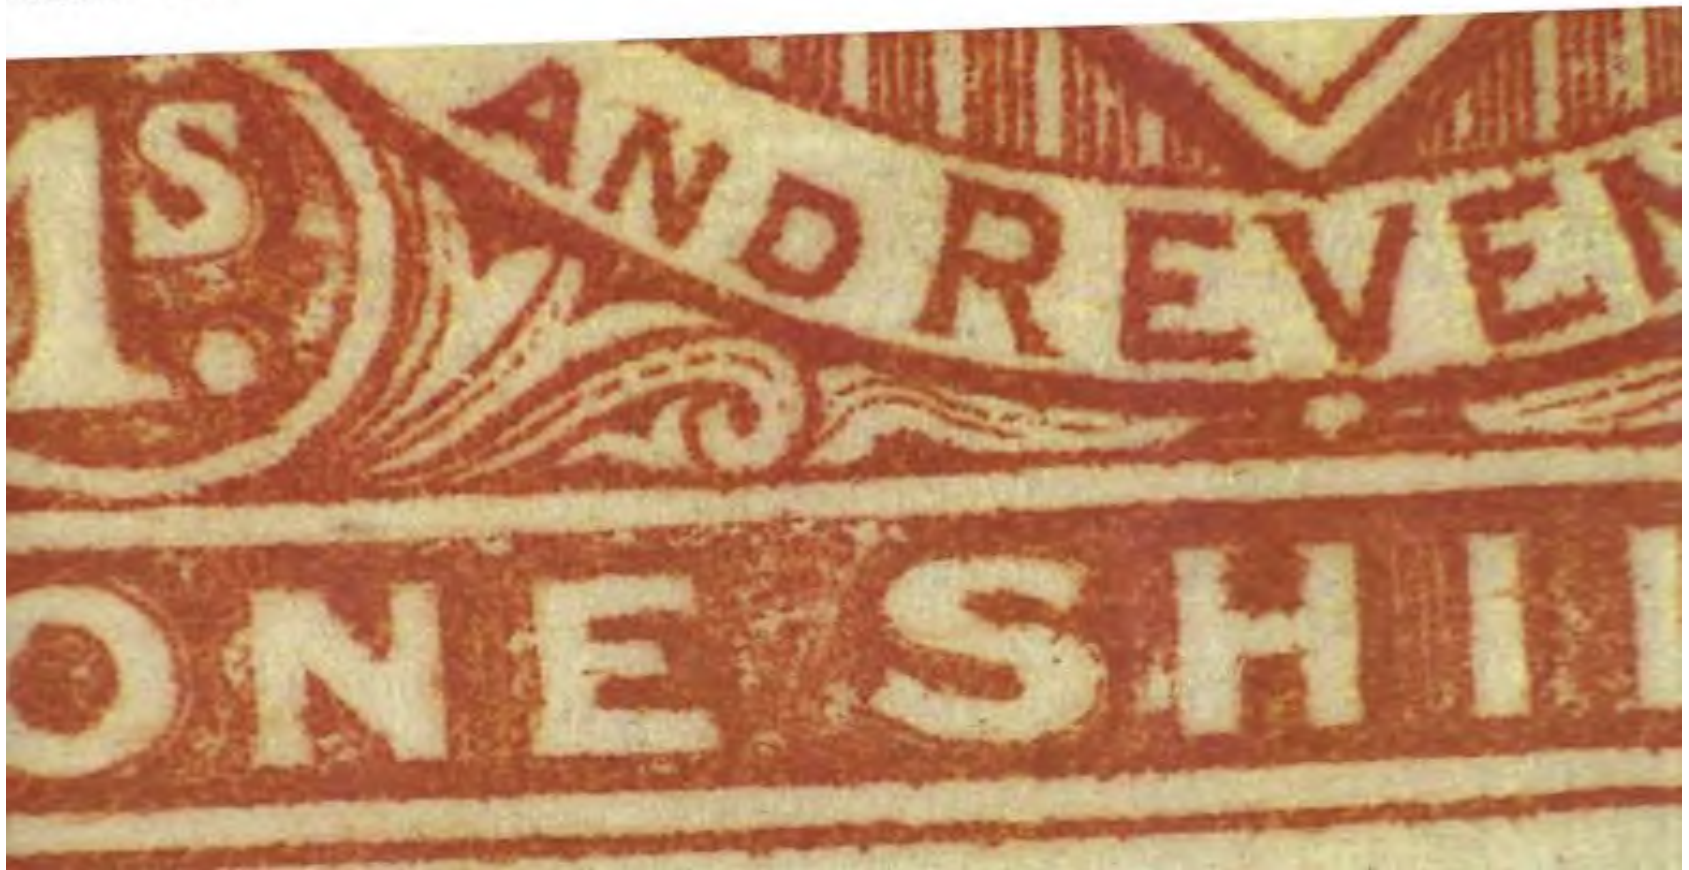
SG385 ? Magnification x 32

VSC8000HS Thu 20/04/2023 13:27:04

, Default, VSC8000HS, Serial Number 43529  
13:27:04 20/04/2023 Lights=Flood (VIS), Longpass=VIS, Mag=31.89, White Balance=139(R) 238(B)  
Auto Exposure (Integration=77ms, Iris=50%), Brightness=50, Gamma=Off, Imaged width=11.6 mm

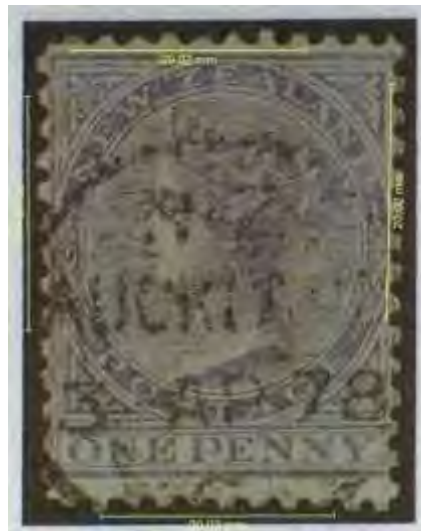
Robin comments on the use of comb & line perforating machines. The latter being deemed the machine used, as the perforations do not align.

The different characteristics produced by the comb and line perforating machines are critical in making a definitive judgement. Both the copies of the 1d that have now been certified provide unambiguous evidence to show they were perforated by the line machine. In both cases the opposite perforation holes do not align, as would be the case with the comb machine: both show frequent clear perforation holes between the horizontal rows of perforations.

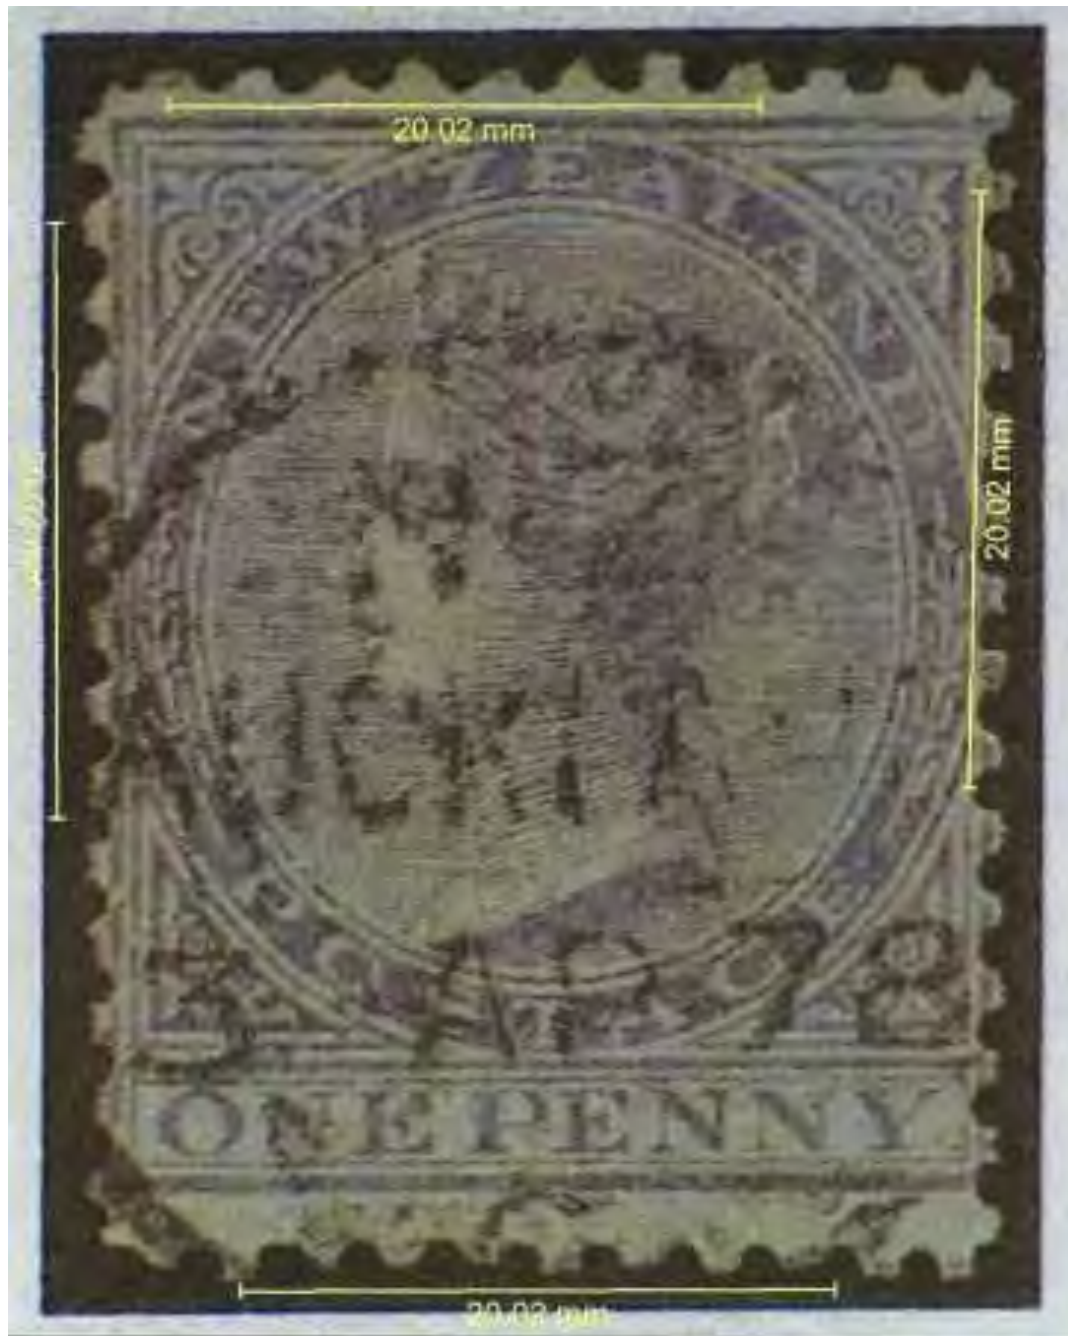
Image  
was  
enlarged  
@ 150%
